# CERTIFICATE OF SUBSTANTIAL COMPLETION

PROJECT: Otter Creek Clubhouse and  
(Name and address) Community Building  
Otter Creek Golf Course  
Ankeny, Iowa

## Punch List

To: Dave Carlson  
From: Jim Harbaugh  
Subject: Otter Creek Punch list  
Date: 6/17/09

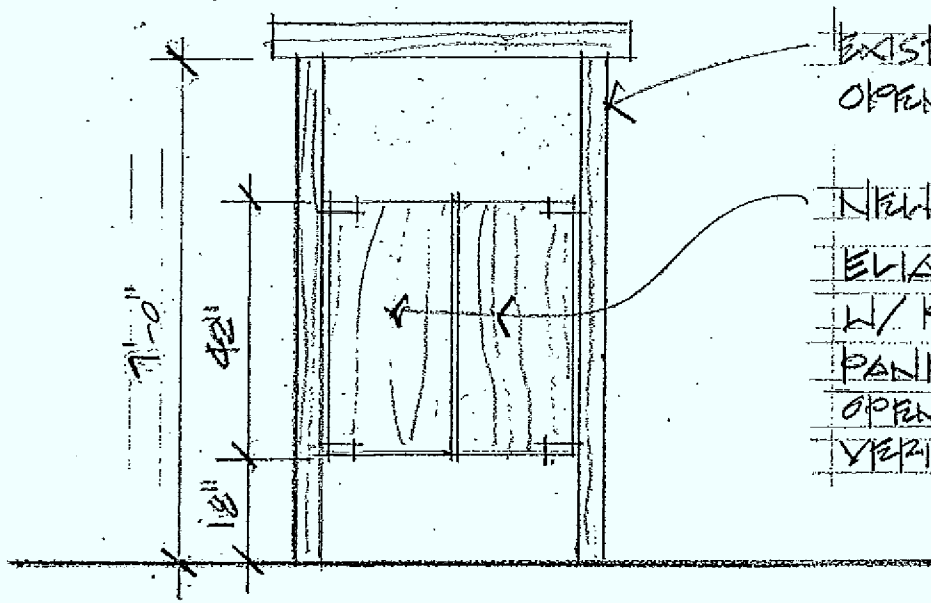
PARTIAL PLAN C BAR 128  
1/8" = 1'-0"

TWO NEW PAIR  
OF DBL. ACTING  
CAFE DOORS

BAR 128

EXIST. WOOD CASED  
OPENING

NEW CAFE DOORS BY S.  
ELIASON. MODEL SCIO. CAFE  
W/ P.V.A.M. FINISH. VERIFY  
PANEL WIDTH W/ CASED  
OPENING WIDTH V.I.F.  
VERIFY P.V.A.M. # W/ APPT.
